Tips for using the Ipas MVA Plus®

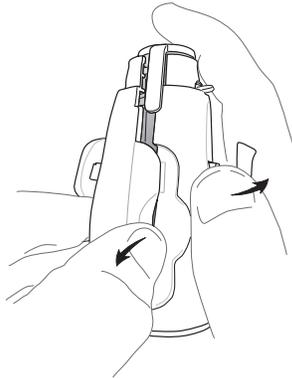
Opening the valve body

Remove valve body from the cylinder. Place right thumb along side the right valve button and left thumb on the valve latch. With the left thumb, pull up and to the left on the valve latch while pushing down and out on the valve body with the right thumb.

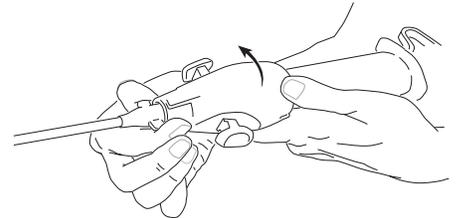
Removal and insertion of Ipas EasyGrip® cannula

If cannula removal is necessary during the procedure: **Stabilize the cannula** by grasping it at the base with one hand and holding it steady; with the other hand, hold the aspirator by the valve body, **rotate the aspirator** and gently separate it from the cannula. To insert the cannula, hold the aspirator by the valve body (not the cylinder), push cannula base in firmly, twisting slightly if necessary.

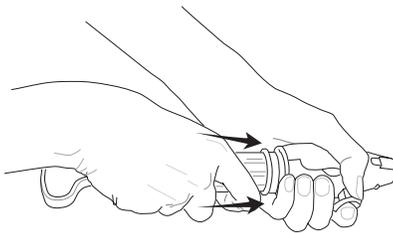
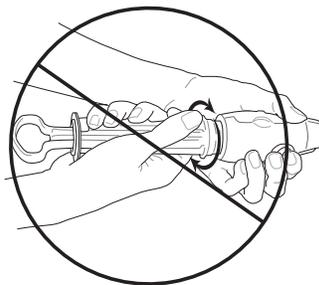
Aspirator assembly

When assembling the aspirator, push the cylinder straight into the valve. Do not twist the barrel or valve when assembling as this will cause the liner to dislodge and may lead to device failure.
